RC
1042
.M38
1990a
c.2

Department
of Transportation
National Highway
Traffic Safety
Administration

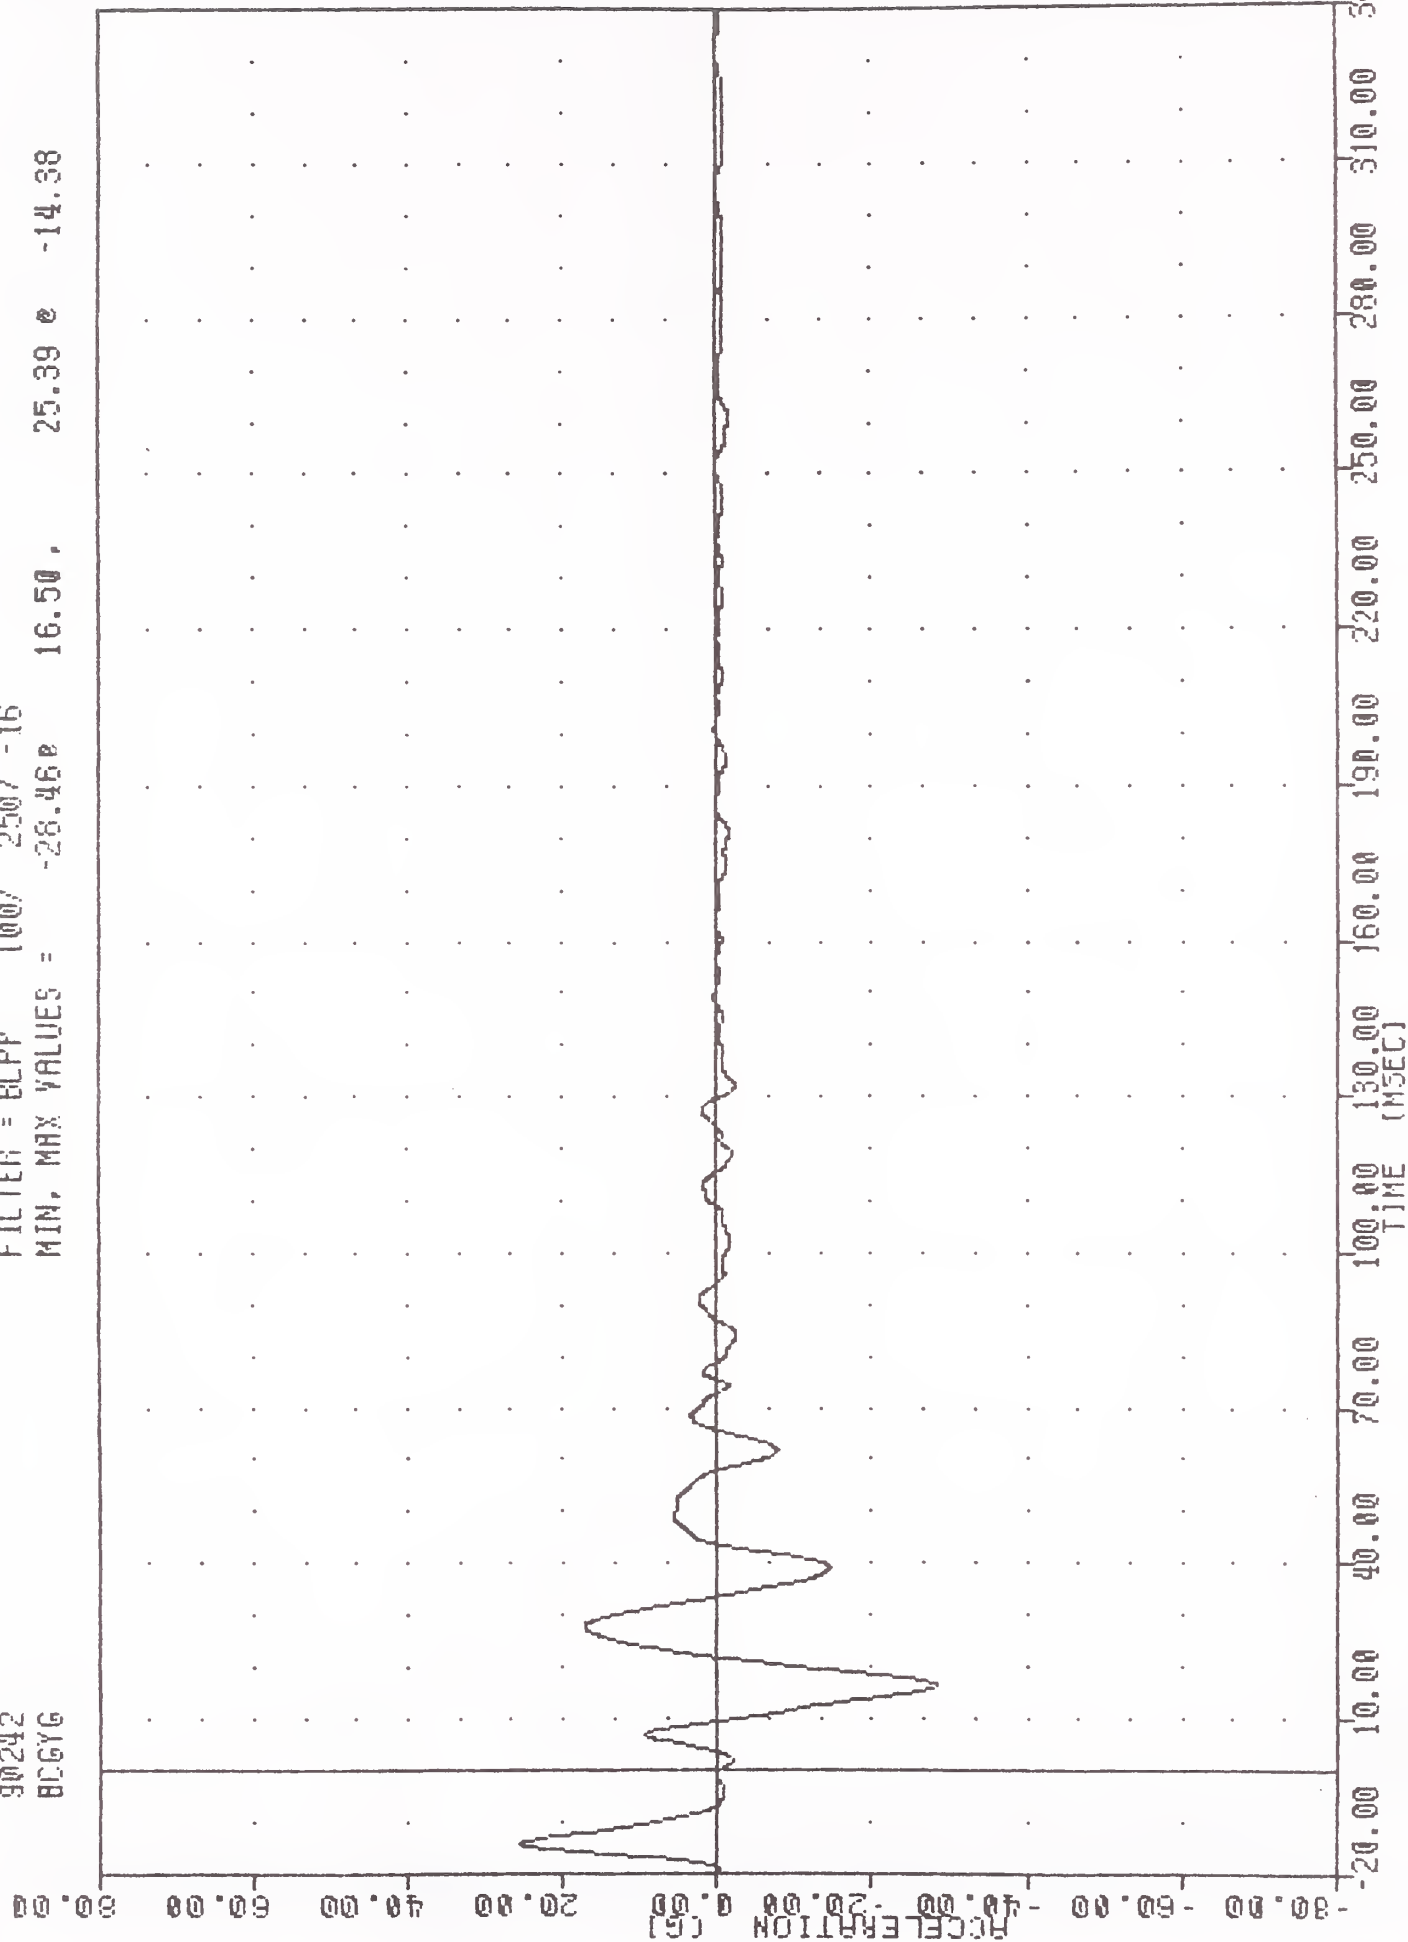
CONToured MOVING BARRIER INTO FORD ESCORT AT 39.8 MPH #4
 MOVING BARRIER CENTER OF GRAVITY Y-AXIS ACCELERATION

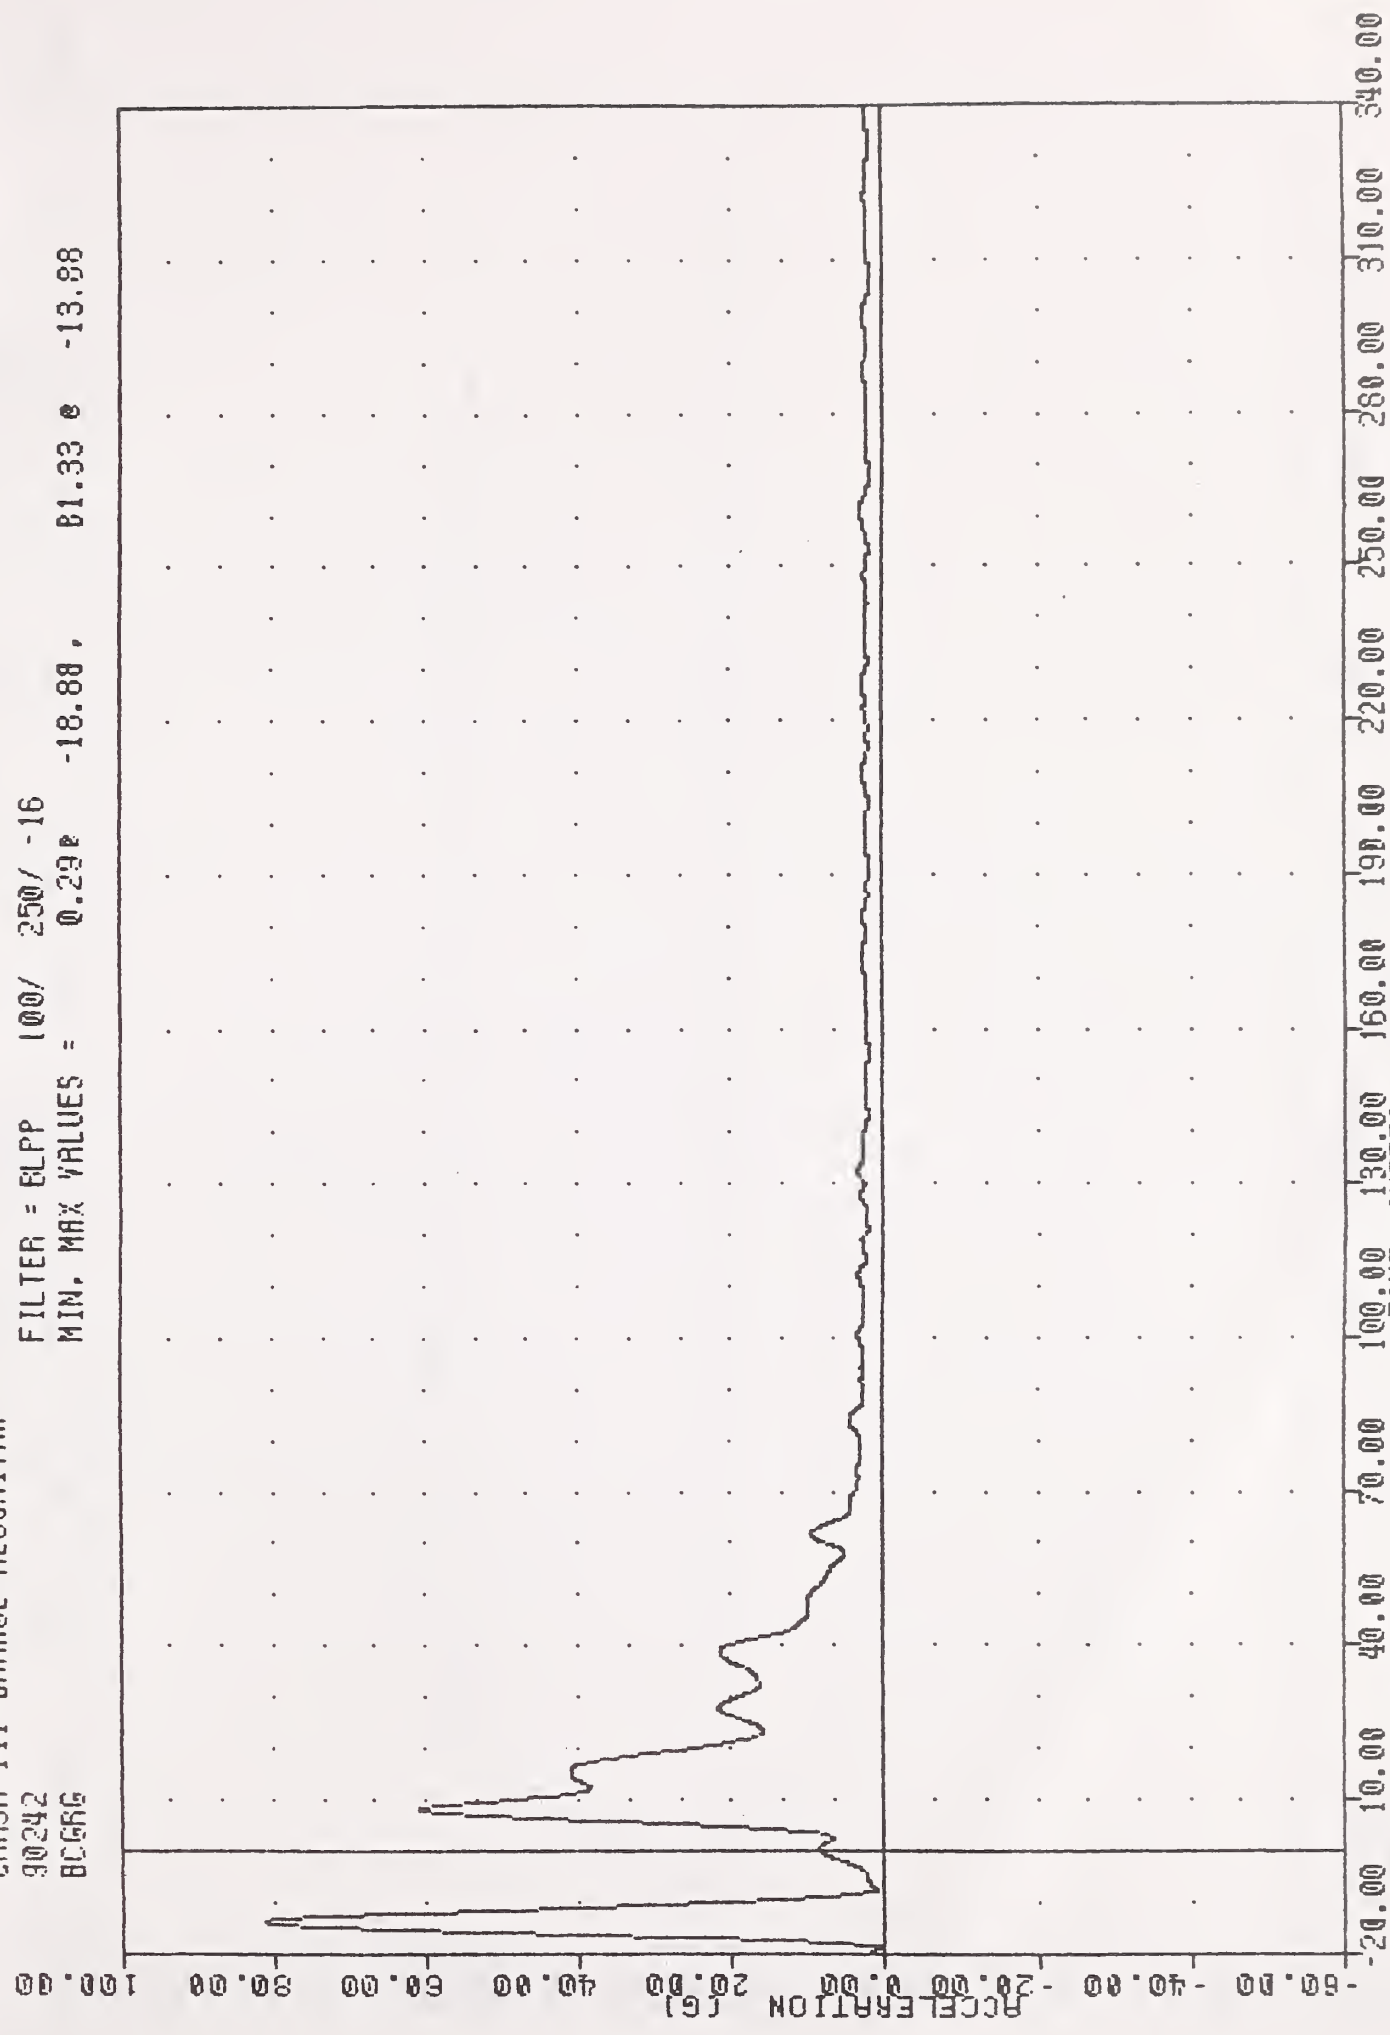
CONTOURED MOVING BARRIER INTO FORD ESCORT AT 39.8 MPH #4
 MOVING BARRIER CENTER OF GRAVITY RESULTANT ACCELERATION

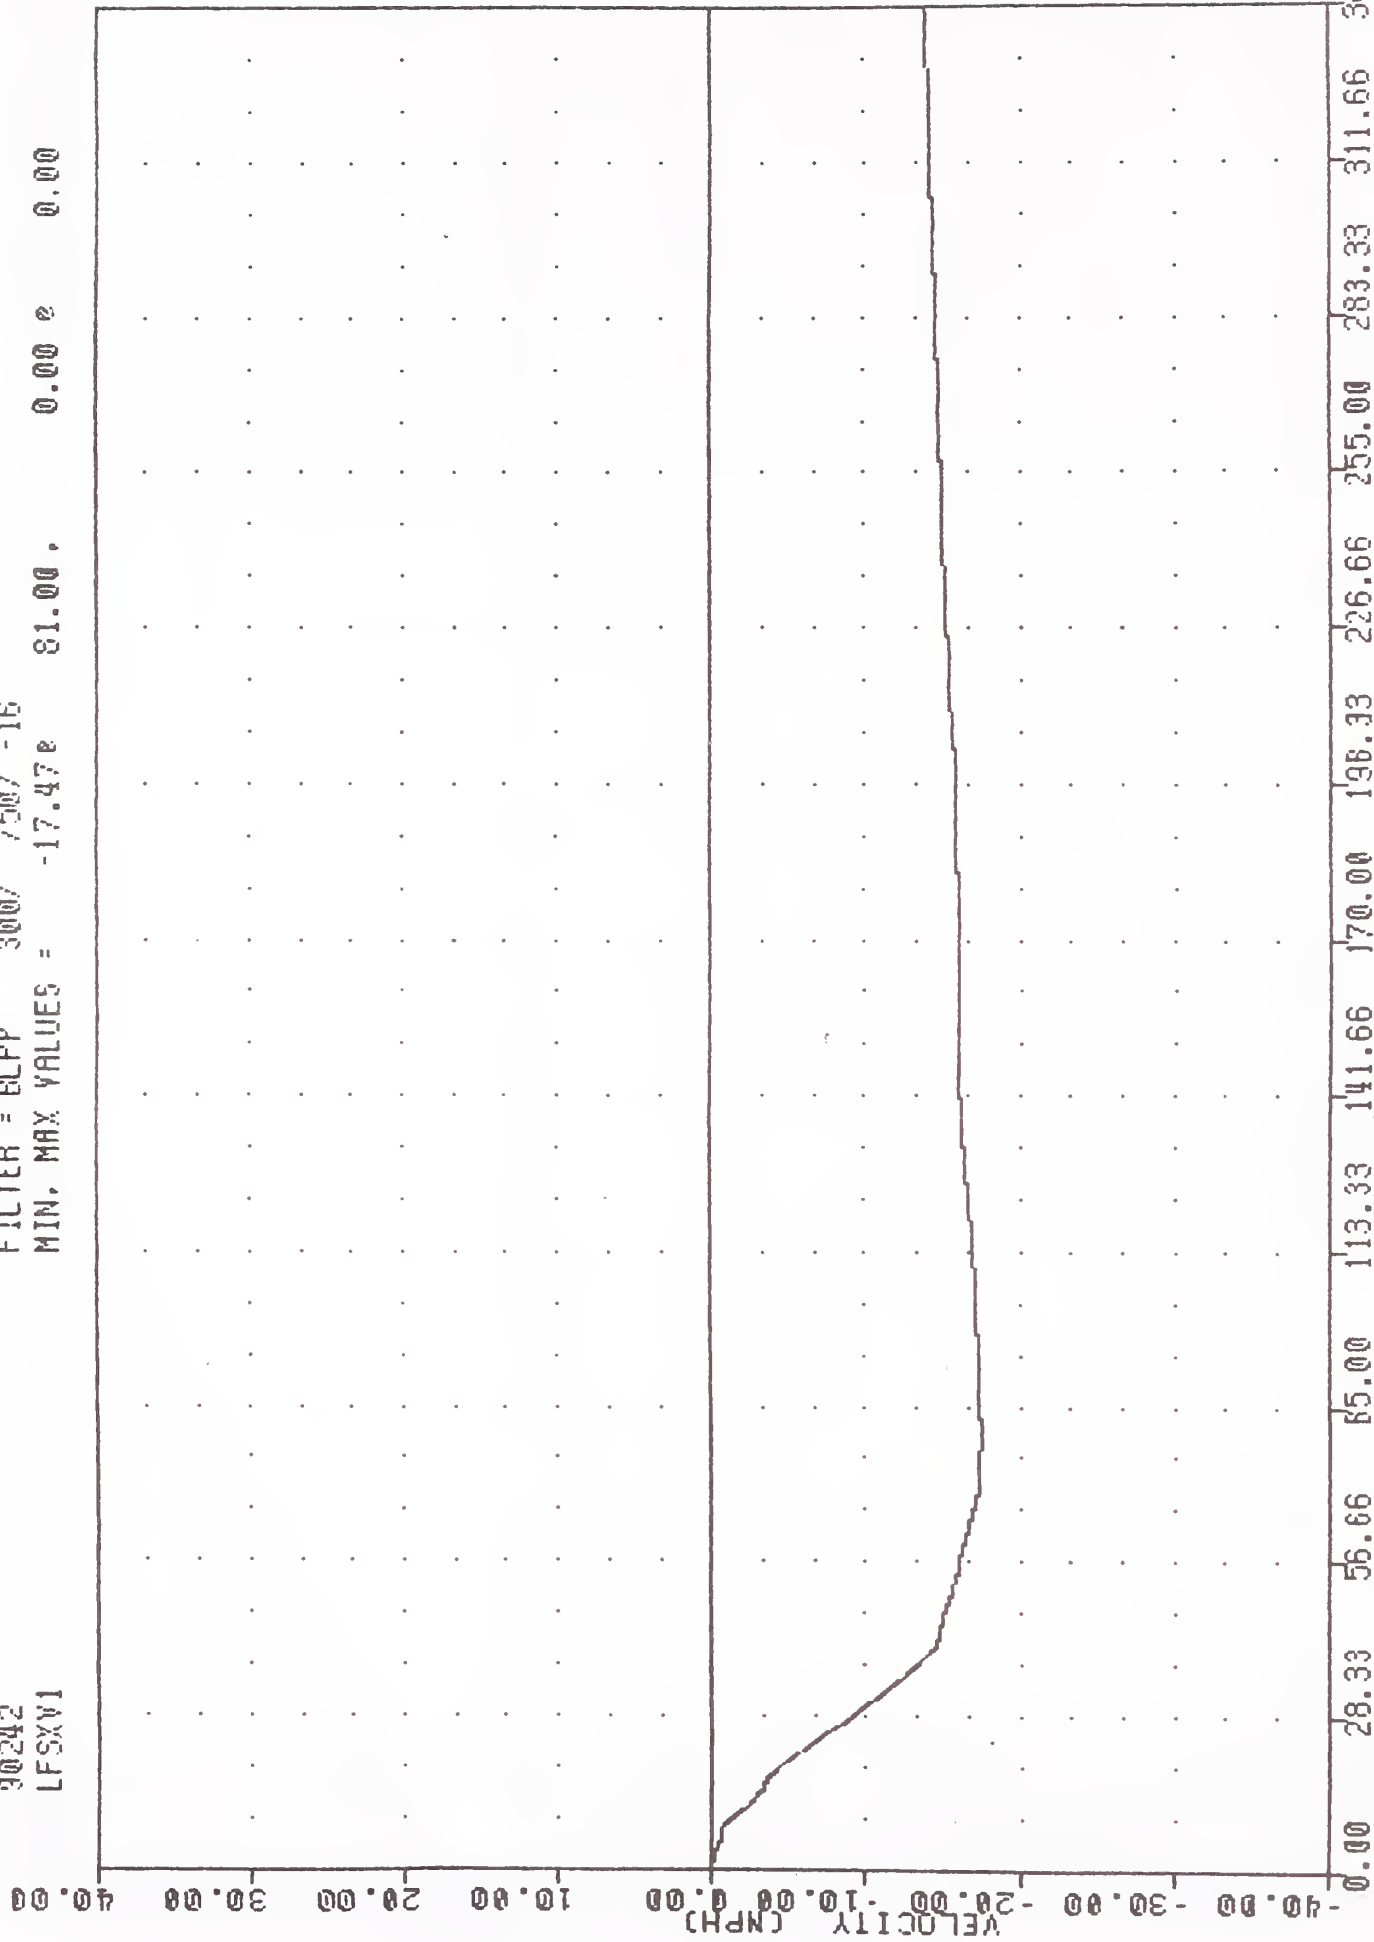
FILTER = BLPP 300/ 750/ -16
 MIN, MAX VALUES = -17.47e 81.00, 0.00 e 0.00

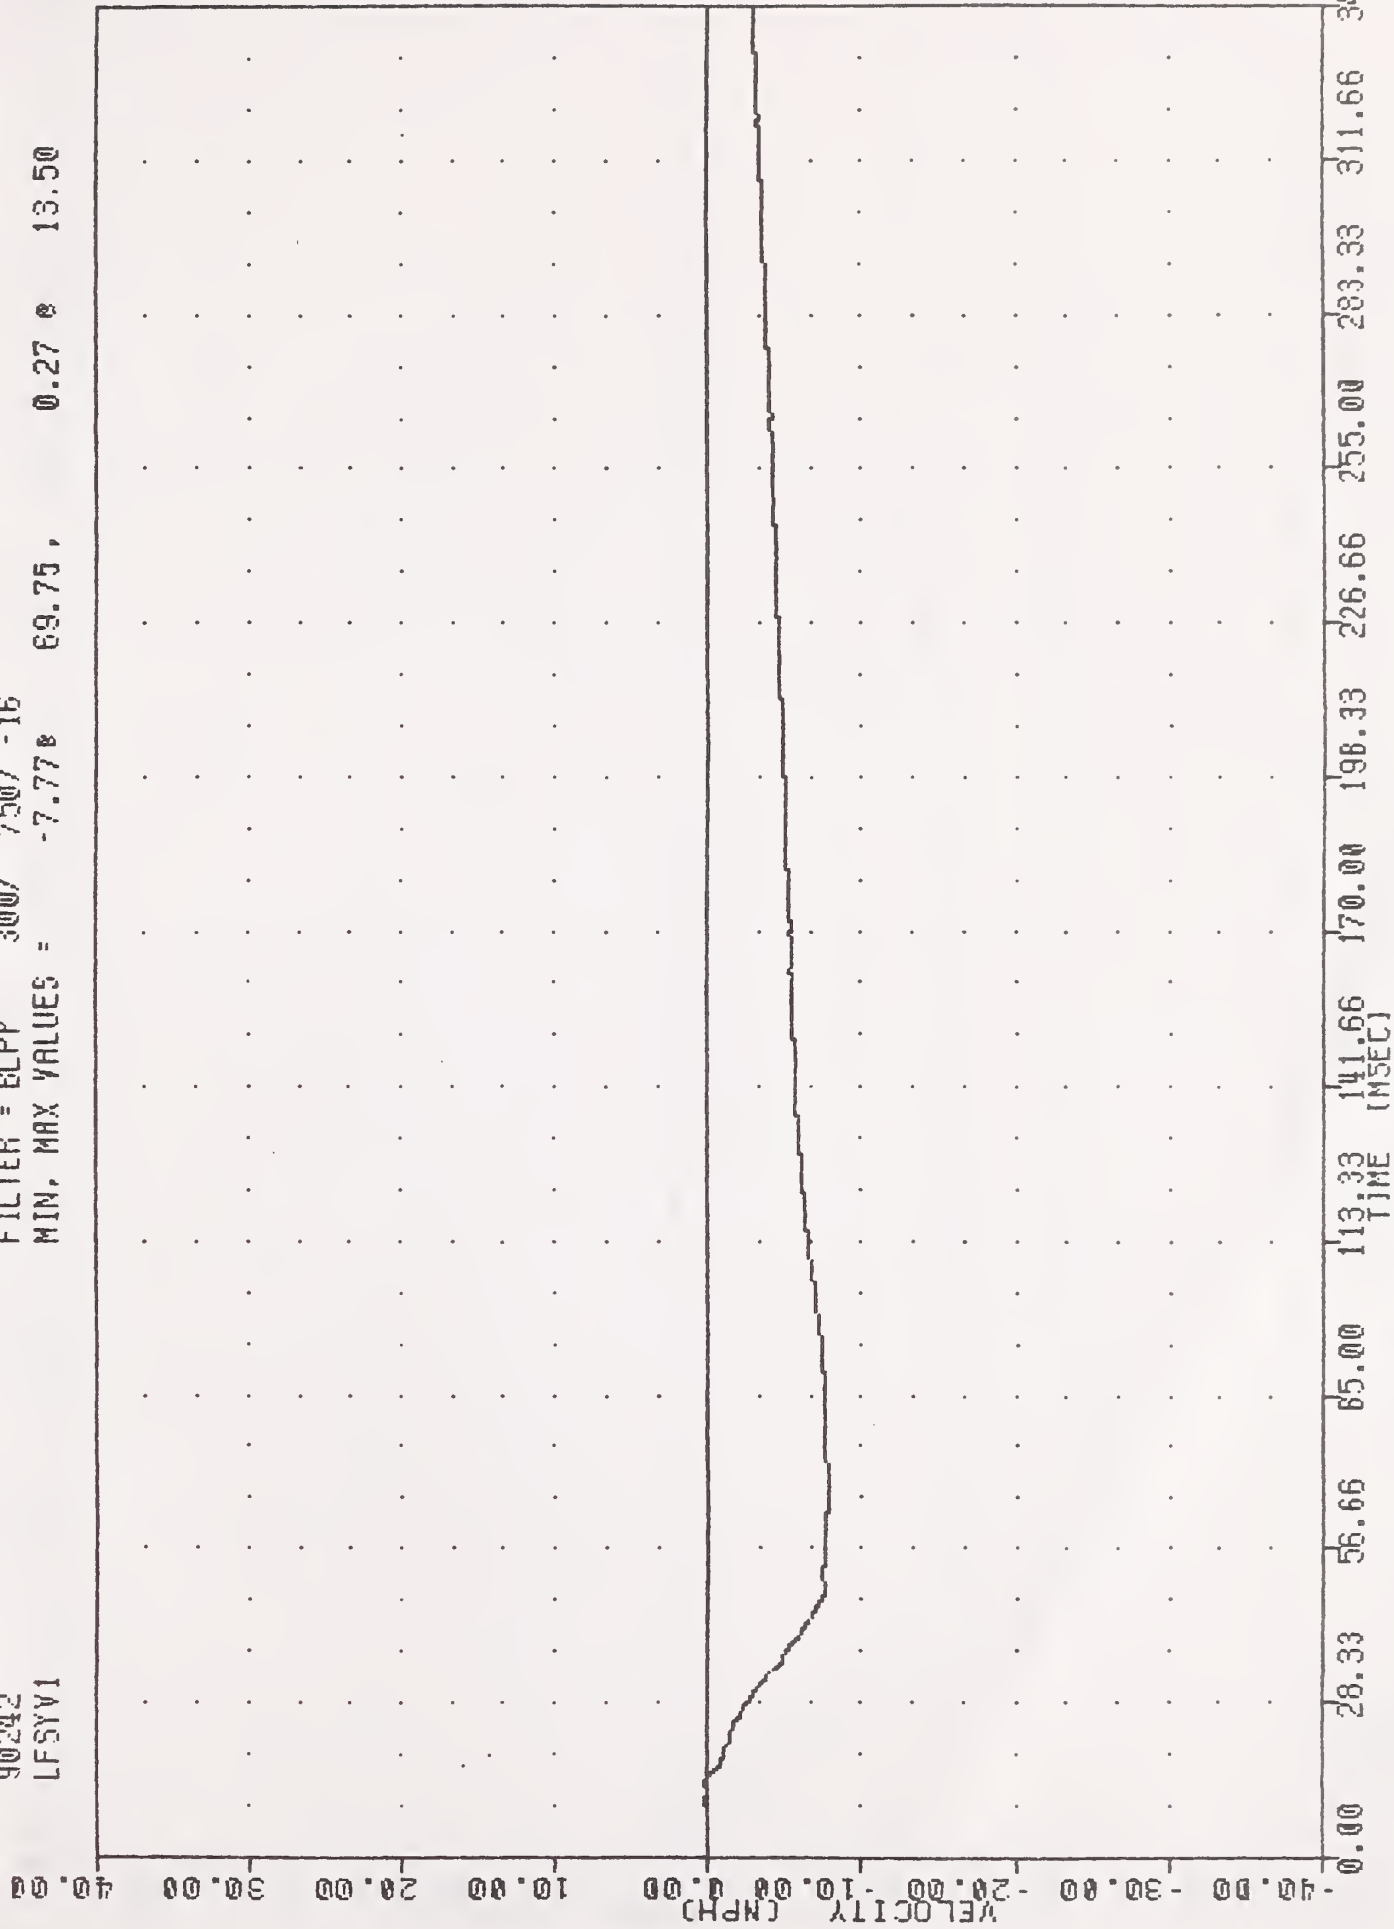
CONTOURED MOVING BARRIER INTO FORD ESCORT AT 39.8 MPH #4
 LEFT FRONT SILL Y-AXIS VELOCITY

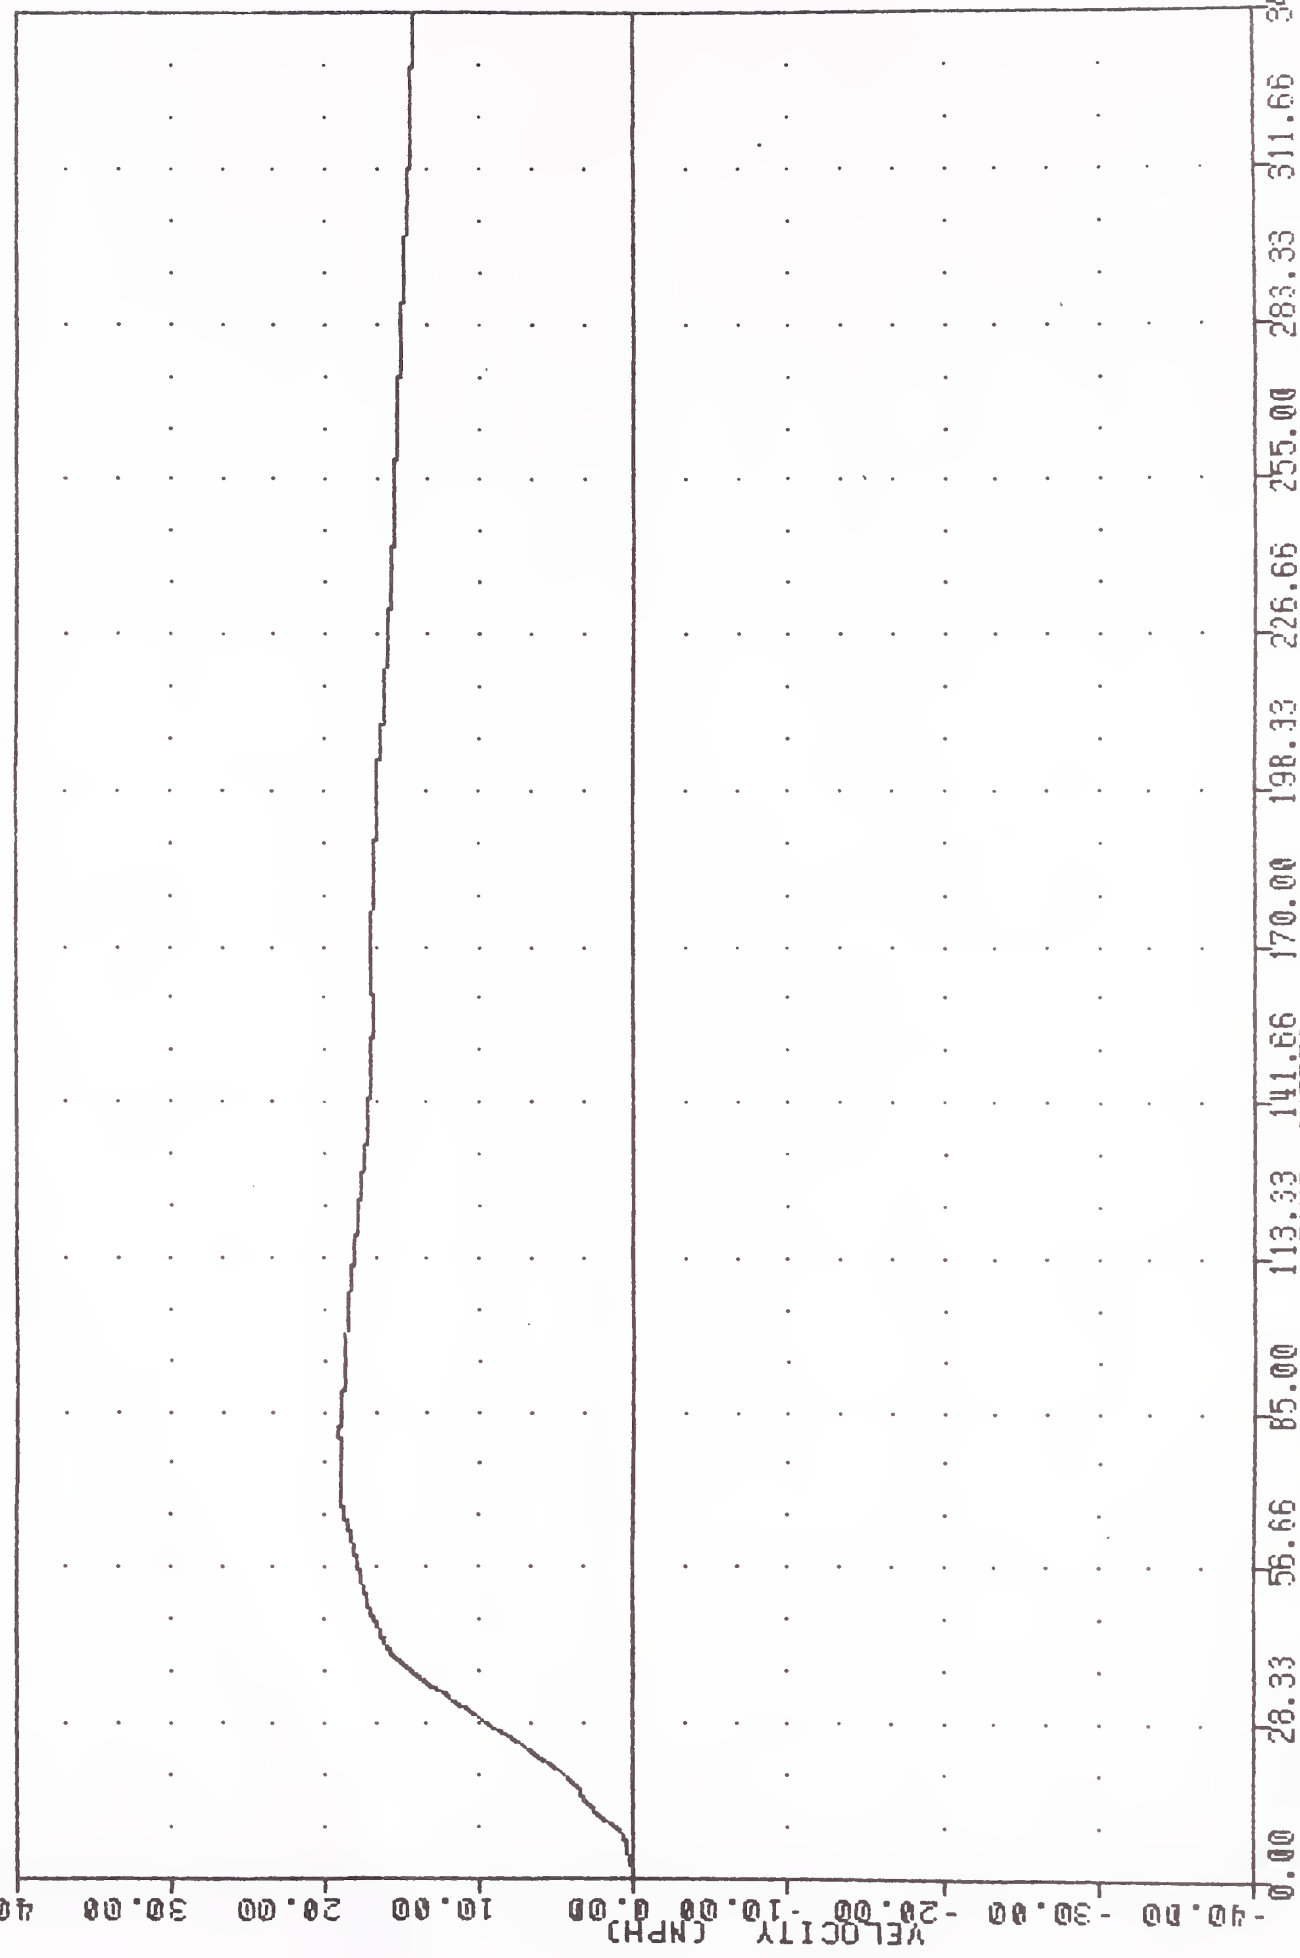
CONTOURED MOVING BARRIER INTO FORD ESCORT AT 39.8 MPH #4
 LEFT FRONT SILL RESULTANT VELOCITY

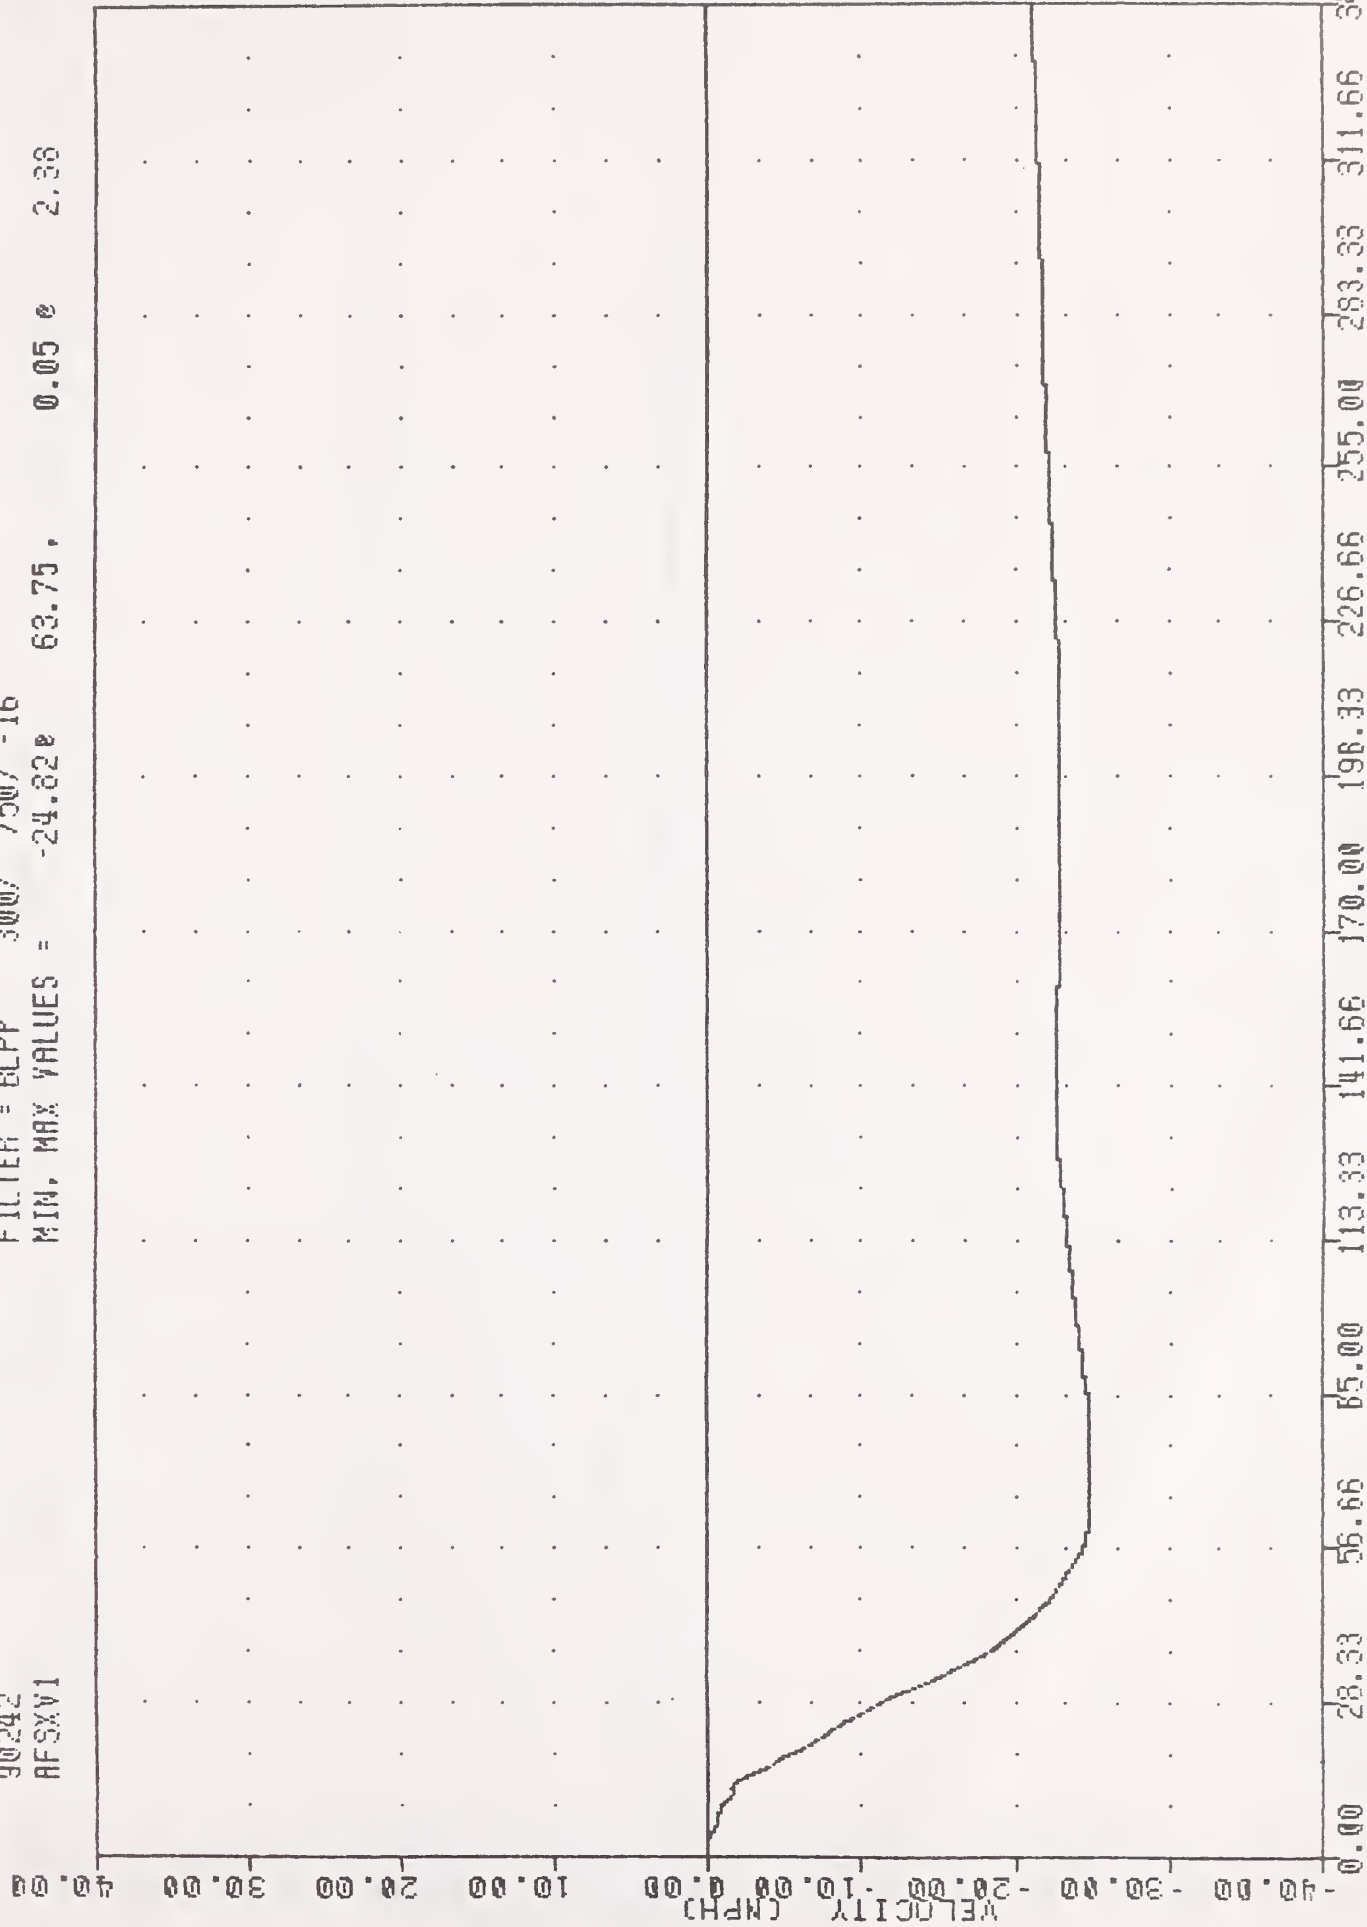
CONTOURED MOVING BARRIER INTO FORD ESCORT AT 39.8 MPH *4
 RIGHT FRONT SILL X-AXIS VELOCITY

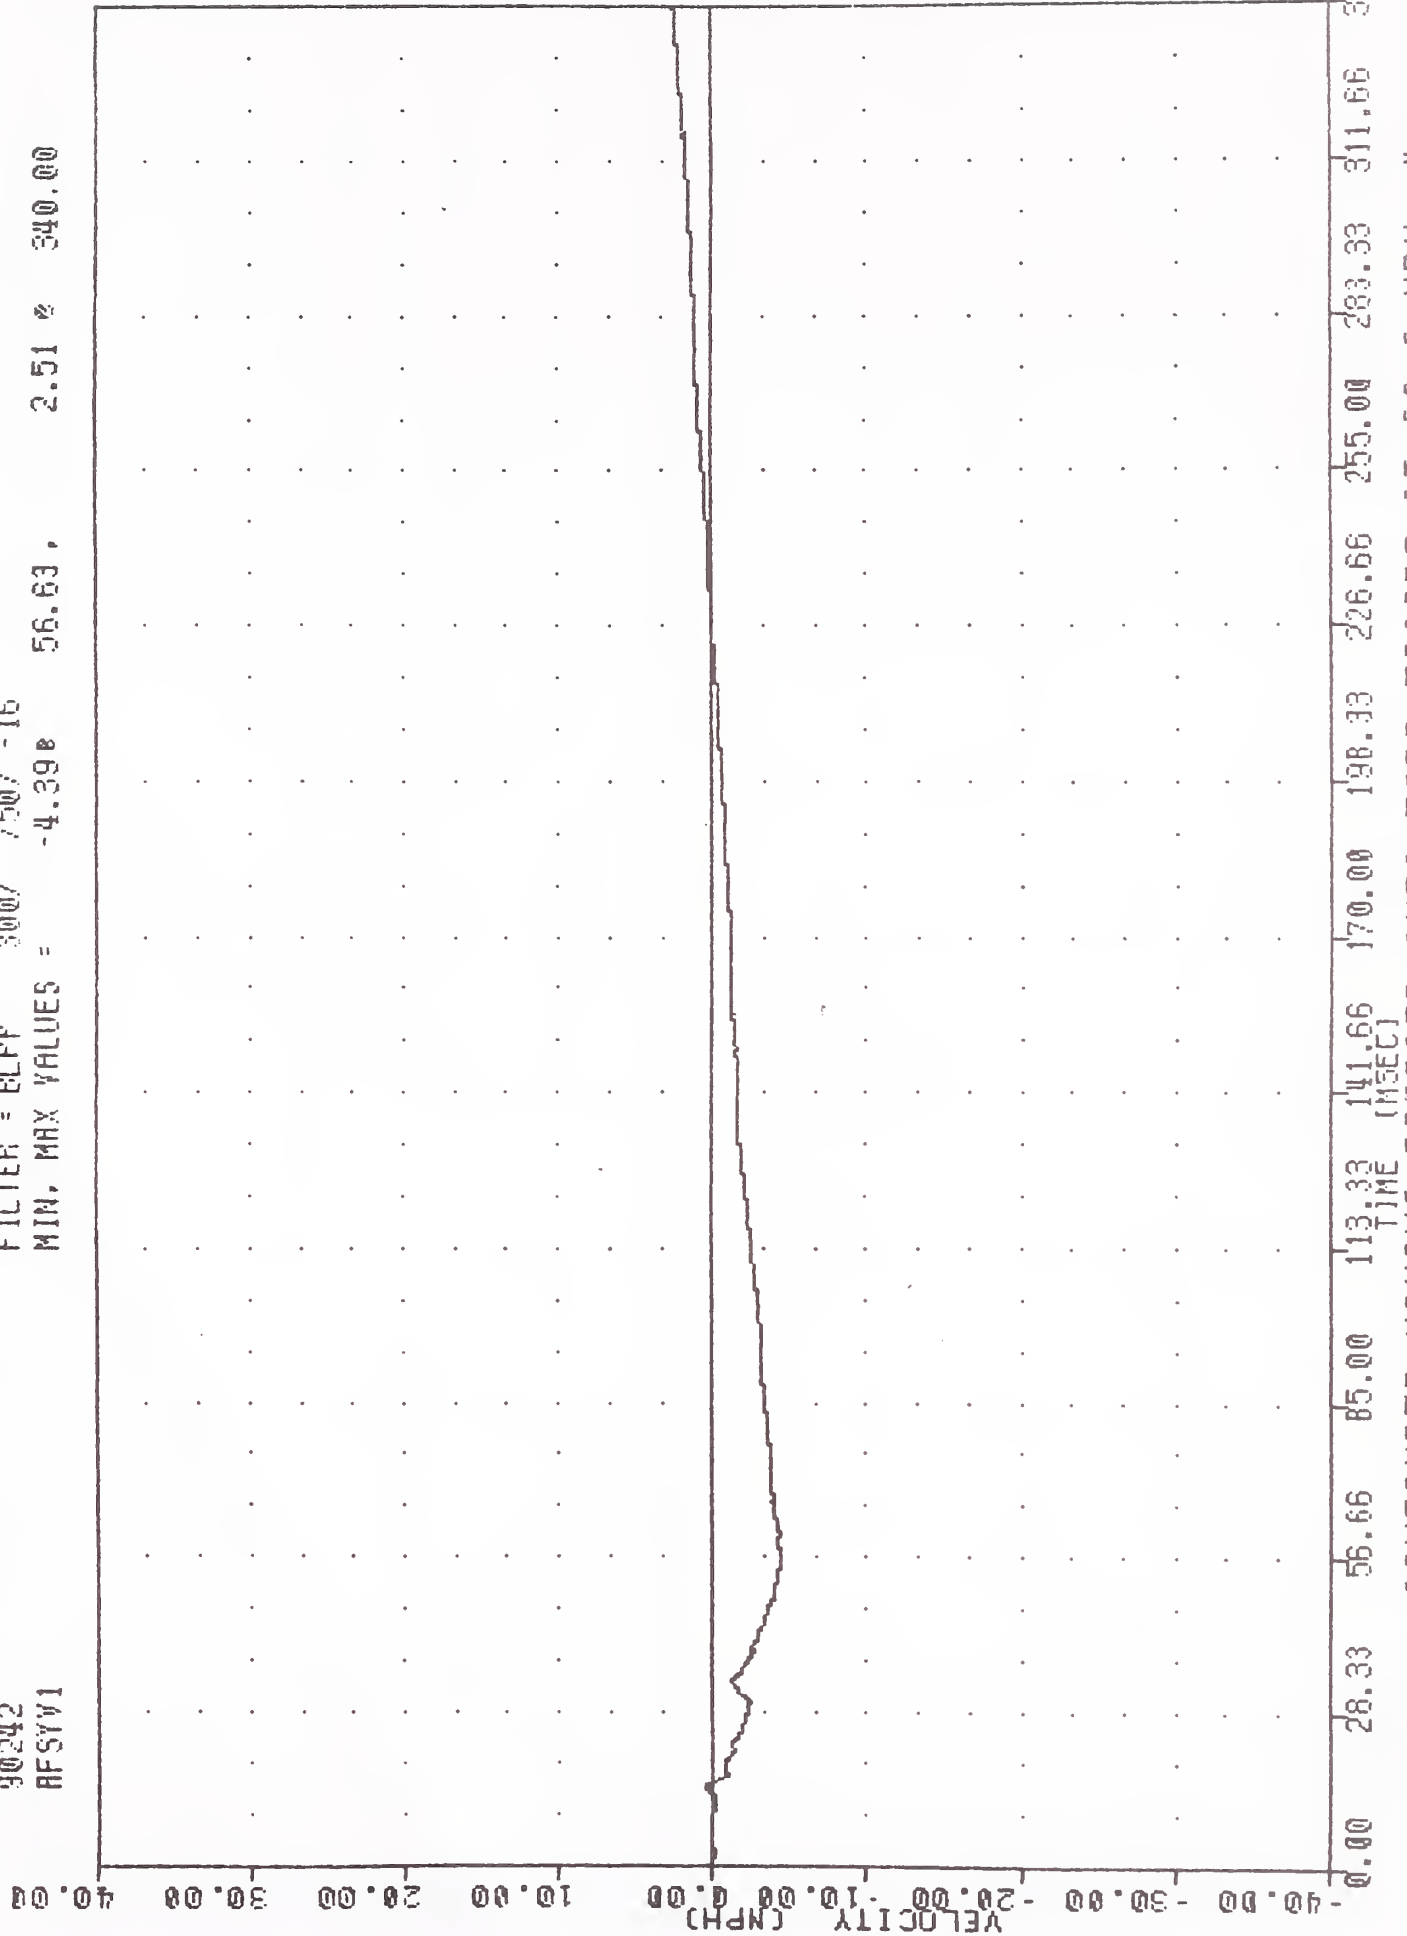
900830-4 , TAC
 CRASH III DAMAGE ALGORITHM
 90242
 AFSRV1

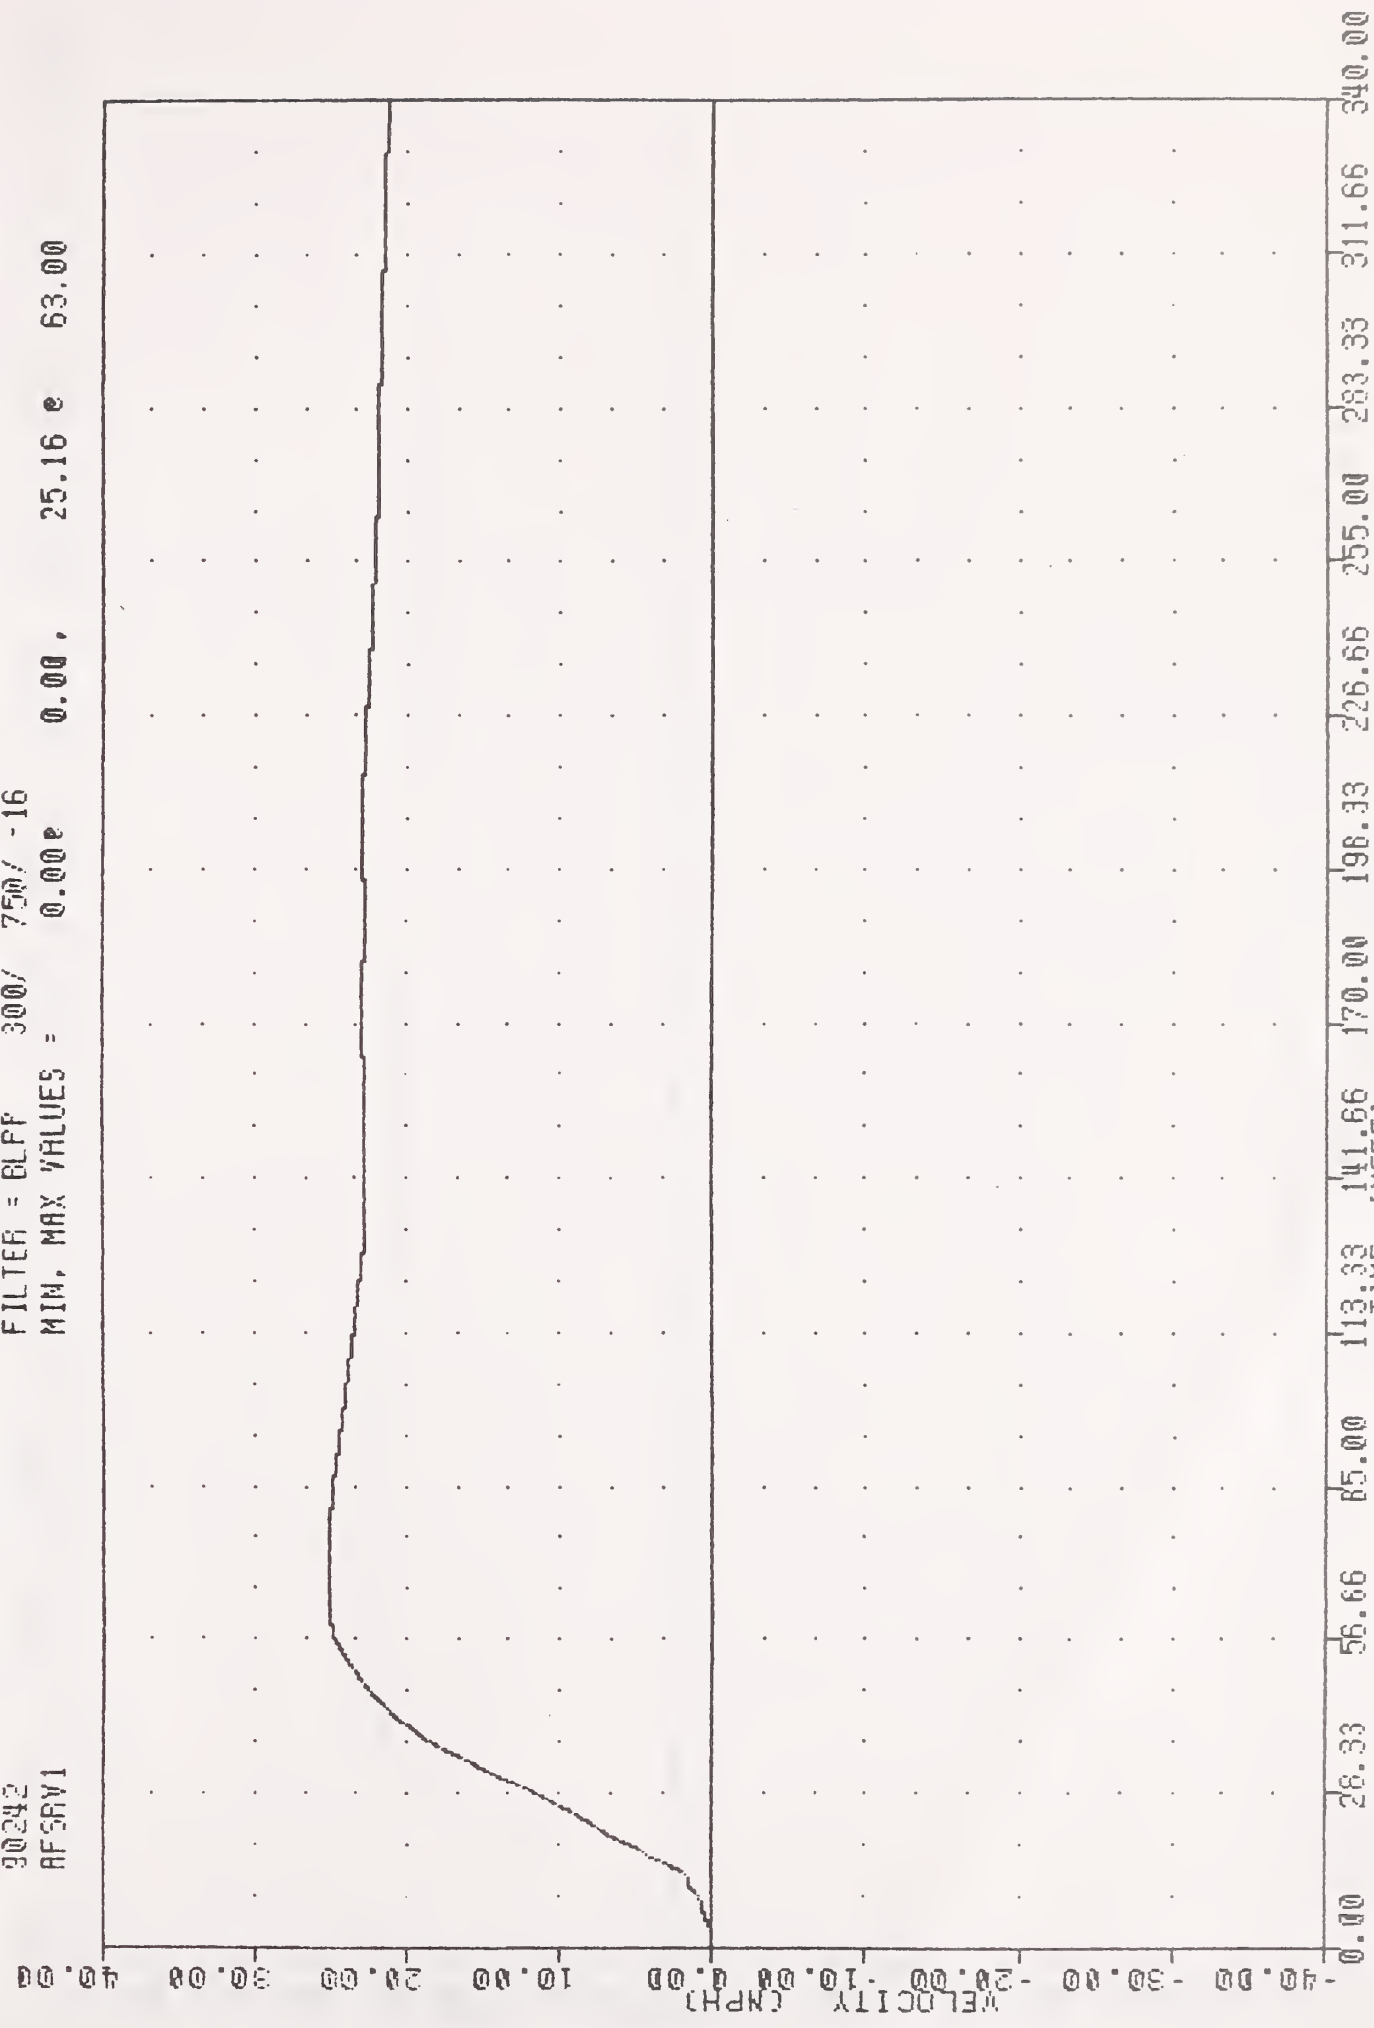
CONTOURED MOVING BARRIER INTO FORD ESCORT AT 39.8 MPH *4
 RIGHT FRONT SILL RESULTANT VELOCITY
